UM-3728-98 1998 Dodge Intrepid

In-depth Vehicle Occupant Report

The University
of Michigan
Transportation
Research Institute

UM-3728-98

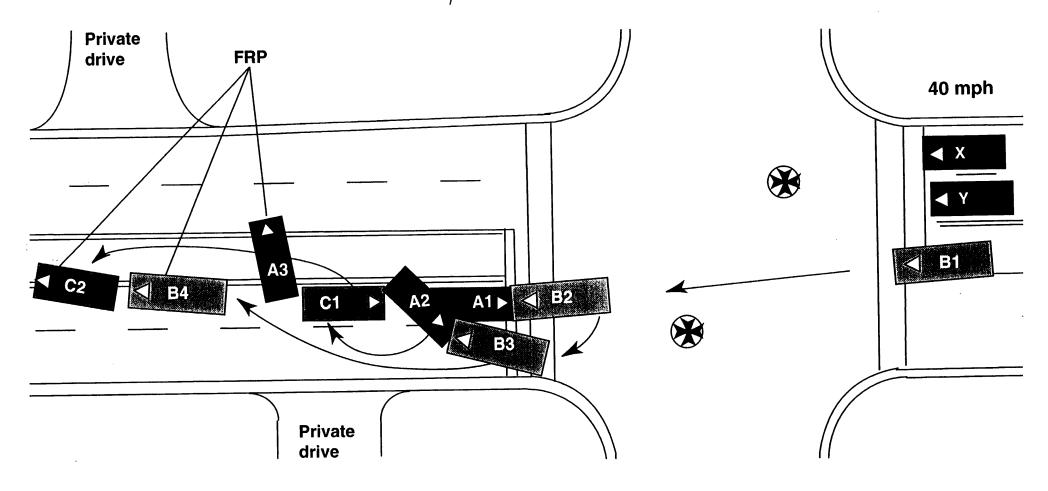
ACCIDENT DESCRIPTION: Case vehicle(A) was stopped for a red light in the west leg of a CASE VEHICLE (A): 1994 Ford 5-150

4-leg intersection, in the inside eastbound lane. Vehicle(C) was stopped behind case vehicle OTHER VEHICLE (B): 1994 Ford 5-150

(A). Vehicle (B) was traveling in the inside westbound lane of the same roadway, approaching THIRD VEHICLE (C): 1997 Mercury Mountaineer stopped trafficat the same intersection. Vehicle (B) crossed into the westbound left-turn lane and went around stopped traffic, traversed the intersection and struck case vehicle (A) head-on. The impact caused case vehicle (A) to rotate dockwise as if was pushed into vehicle(C). Case vehicle (A) struck the left front of vehicle (C) with its right quarter panel, causing vehicle (C) to rotate counter clackwise approximately 180 degrees, before coming to rest in the earthound left-turn lane. Vehicle (B) Came to NORTH rest behind the rear end of Vehicle (C), head in the same direction. Case vehicle (A) came to rest straddling the left-turn lane and the inside westbound lane, rotated approximately 260 degrees from its original heading.
